Physical Property Committee

Administration Conference Room

Urban Crossroads, Inc. is pleased to submit this letter report documenting our review of circulation and roadway design conditions along Saint Andrews Drive from Golden Rain Road to (and including) the entry gate area west of Seal Beach Boulevard. For ease of reference, Saint Andrews Drive is referred to as an east-west oriented roadway, although there is an angle in the alignment at Church Place that results in a diagonal alignment between Golden Rain Road and Church Place. The purpose of this circulation review is to assess the movement and connectivity of walkways, bikeways, and the general utilization of the street area / right of way to facilitate the movement of pedestrians, bicycles, and various vehicle types that are likely to be present (golf carts, transit services, automobiles, and trucks).

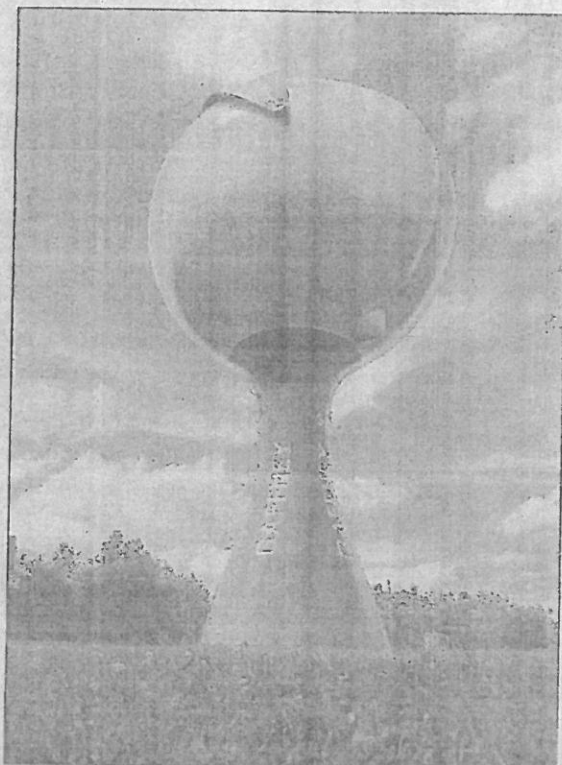
TALK IN TOWN was that the water tower resembling a peach, a fixture since 1981, was being torn down. In fact, it is just getting a paint job.

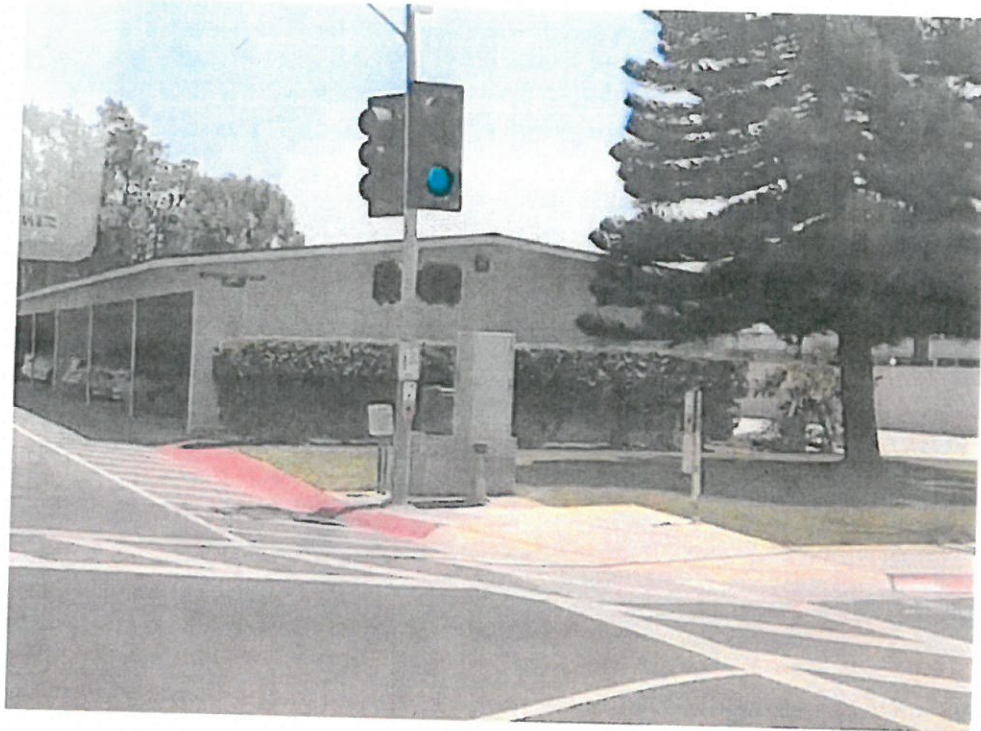
1. End of sidewalk forces pedestrians to walk on roadway.

- 1.1 Extended sidewalk on SE corner of Golden Rain Road and Saint Andrews Drive. Existing conditions force pedestrians to walk in the street in order to access carport. {Easy targets for NB cars turning right onto Saint Andrews Drive}
- 1.2 Added channelized striping at all carport exit/entry points.
- 1.3 Added additional median breaks along Saint Andrews Drive.
- 1.4 Modified all crosswalks with enhanced/colored paving.
- 1.5 Recommend replacing existing trees in the median that with a species that allows for high-profile vehicles to travel under. Remove the existing signs are posted along median that prohibit/warn high-profile vehicles from using inside lane (example: palm trees staggered and off-centered to avoid existing power lines). Working with the utility companies to underground the existing utility lines would further enhance the character of the streetscape.

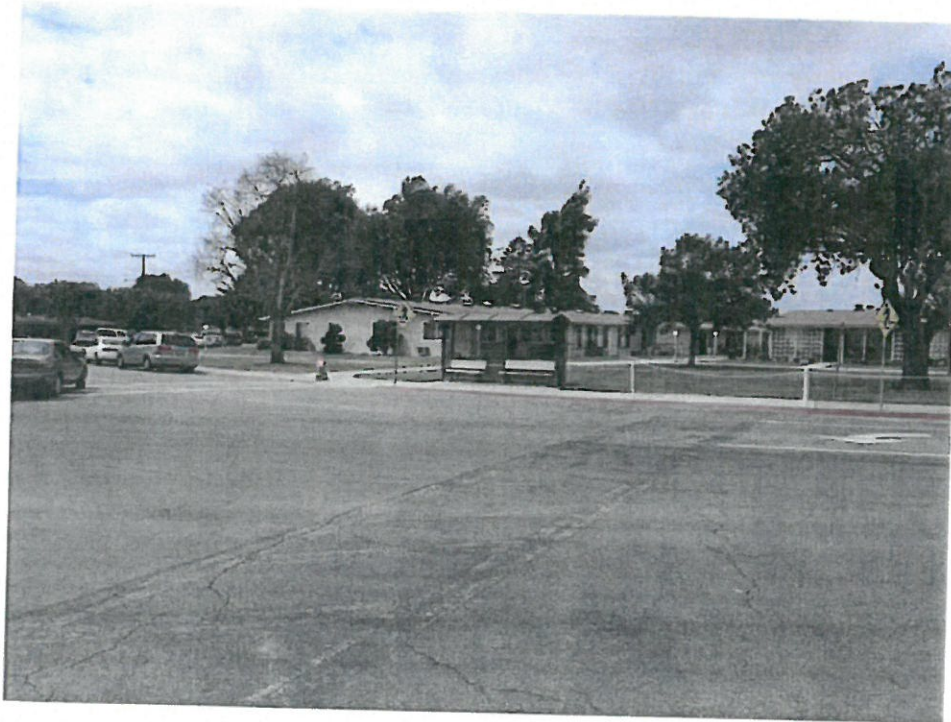
2. Typical bus stop shelter along Saint Andrews Drive.

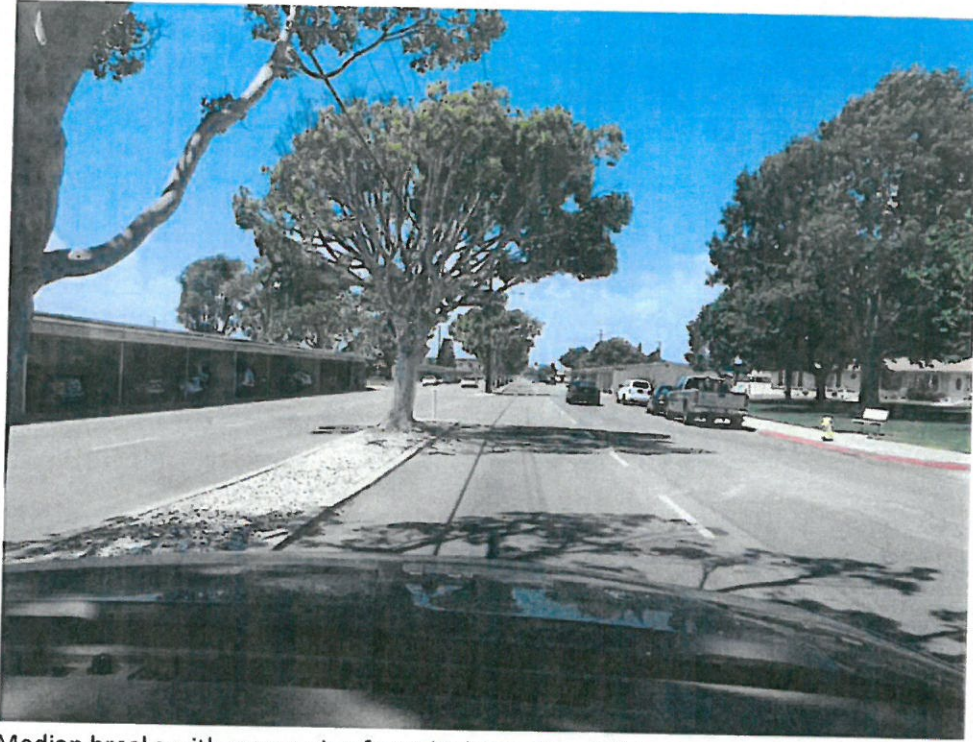
3. Median breaks with no queuing for vehicles making left turn or u-turn.

- 2.6 Added median breaks along Saint Andrews Drive.
- 2.7 Added two-way-left-turn (refuge) lanes within median breaks. This removes the vehicles from the through travel lanes and eliminates vehicles making turns from the through lanes under existing conditions.

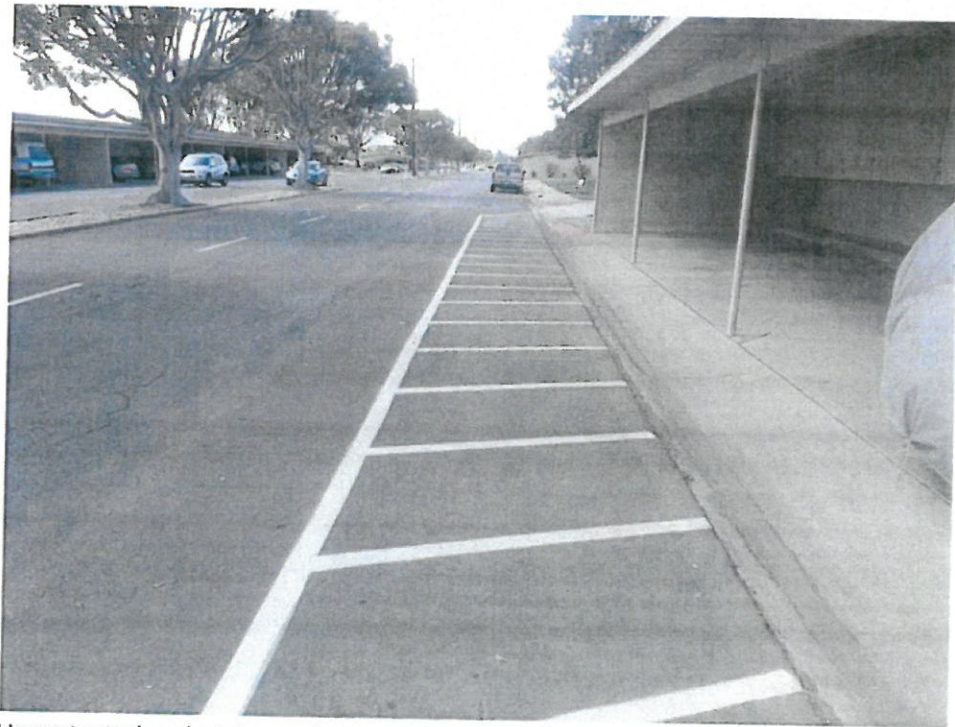
4. Unprotected pedestrian path accessing car ports.

- 2.3 Extended sidewalk on SE corner of Golden Rain Road and Saint Andrews Drive. Existing conditions require pedestrians to walk in the street in order to access carport.

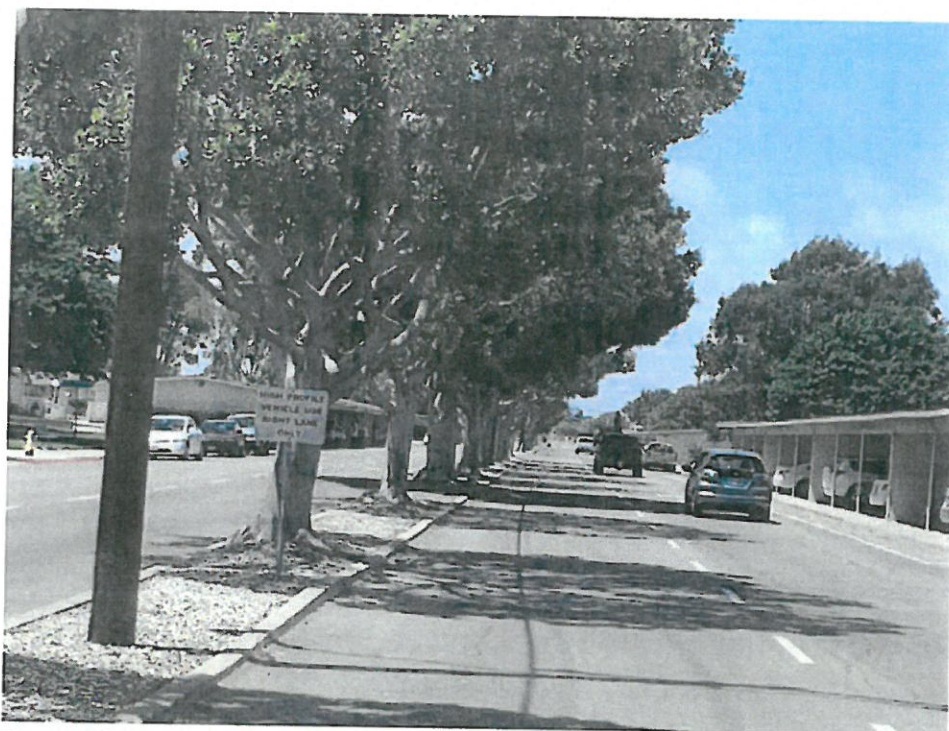
5. Trees within median prevent high profile vehicles from using inside lane.

- 2.8 Replace existing trees in the median with a species that allows for high-profile vehicles to travel under. Existing signs are posted along median that prohibit/warn high-profile vehicles from using inside lane.

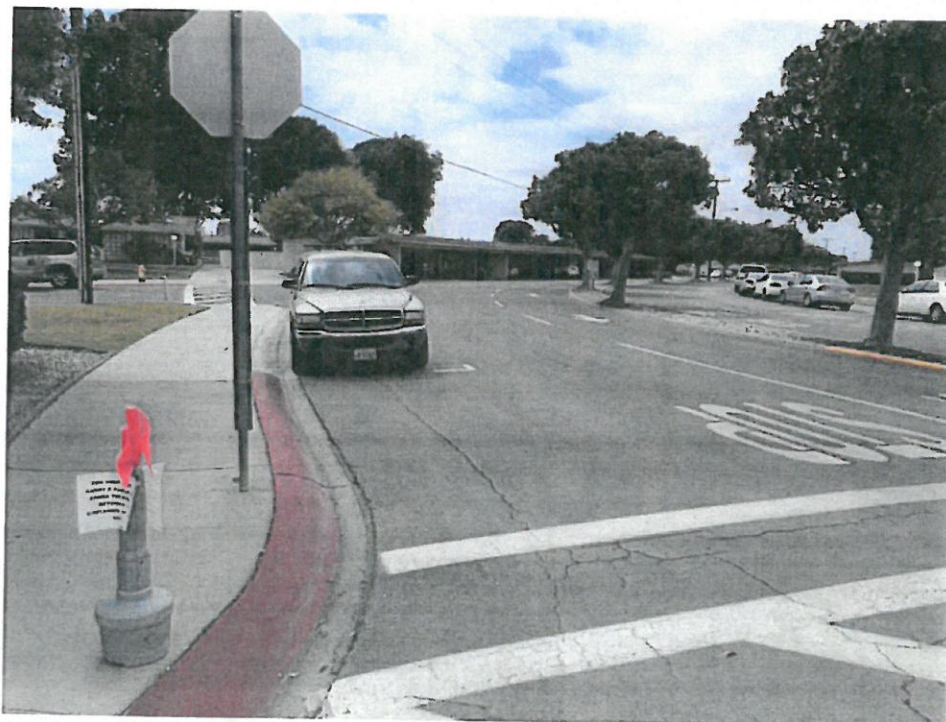
6. On-street parking along median conflict with line of sight.

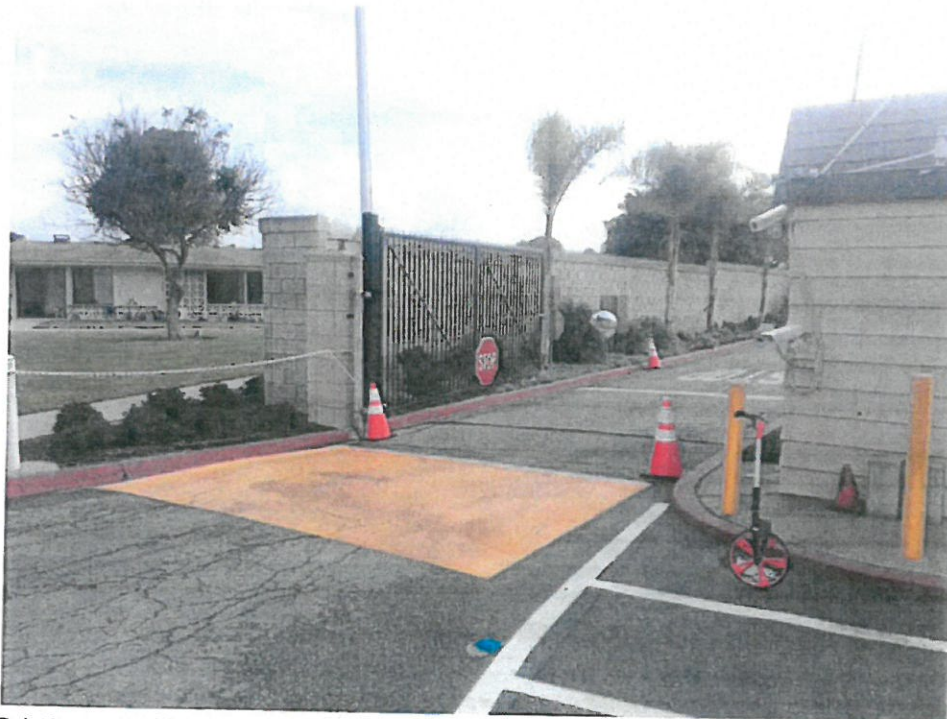
8. Existing speed hump at entry gate.

- 2.13 Added pedestrian gate on north side of entry gate.
- 2.14 Relocated and painted chevrons on speed humps per MUTCD Figure 3B-29 (Option C, Page 756).
- 2.15 Added striping outside entry gate to direct vehicles exiting gate, exiting/entering commercial site.
- 2.16 Provided angled parking exiting the gate and removed conflicting rail just outside gate. {see field photos}
- 2.17 Added sidewalk on south side of Saint Andrews Drive exiting the gate. Existing conditions force pedestrians to walk on pavement in between travel lane and parked cars.
- 2.18 Eliminated one EB thru lane on Saint Andrews Drive to reduce vehicle/pedestrian conflict.

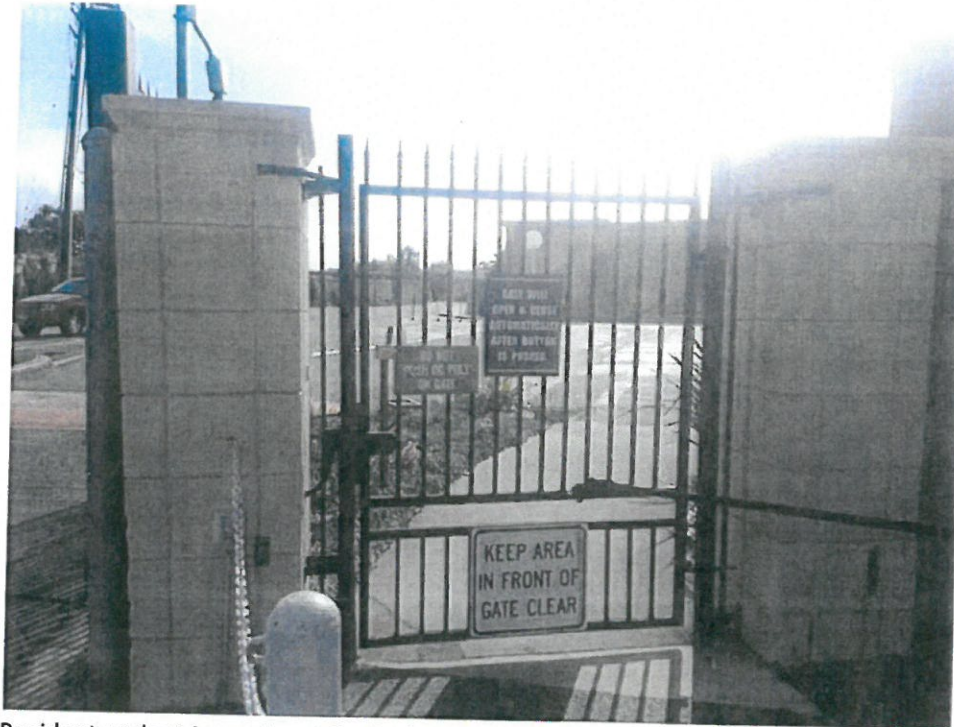
9. Resident pedestrian entry at St. Andrews gate.

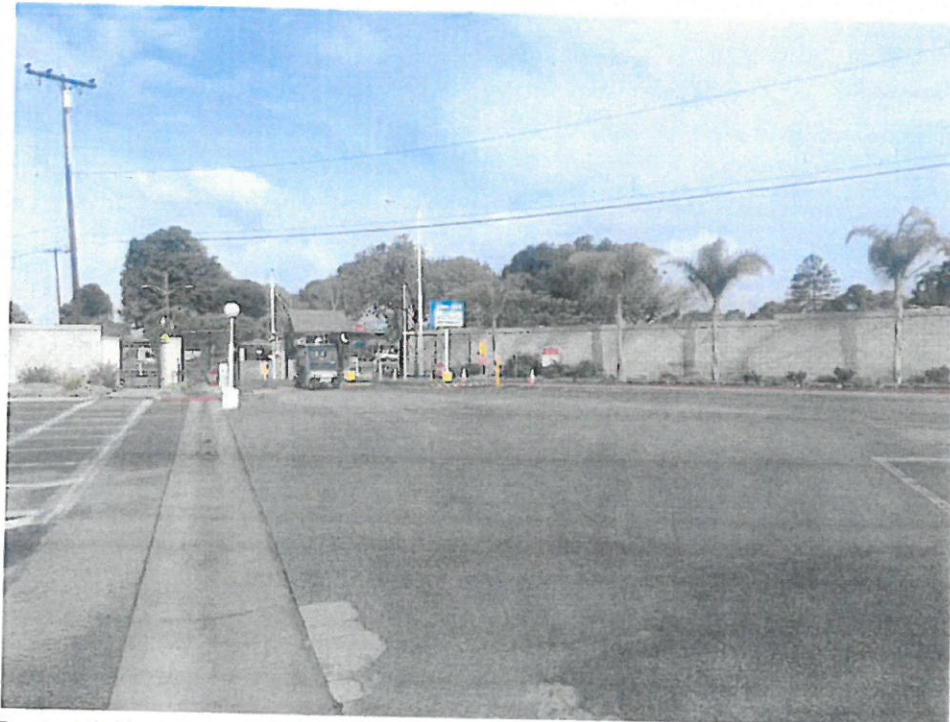
10. Potential dilemma/conflict area exiting St. Andrews gate.

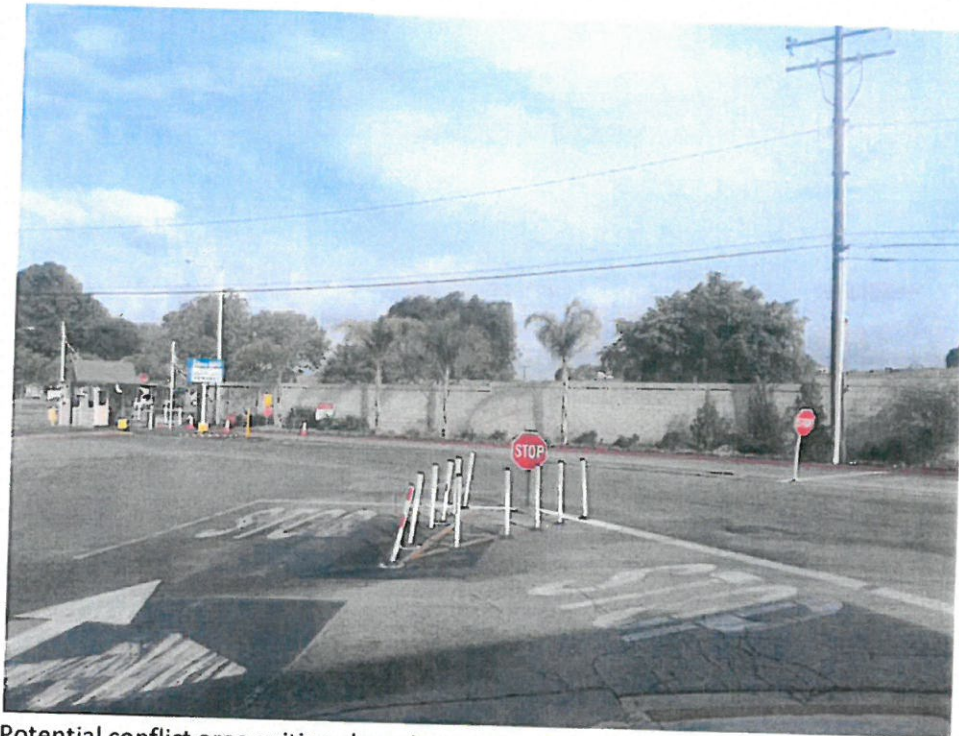
11. Potential conflict area exiting shopping center at St. Andrews gate.

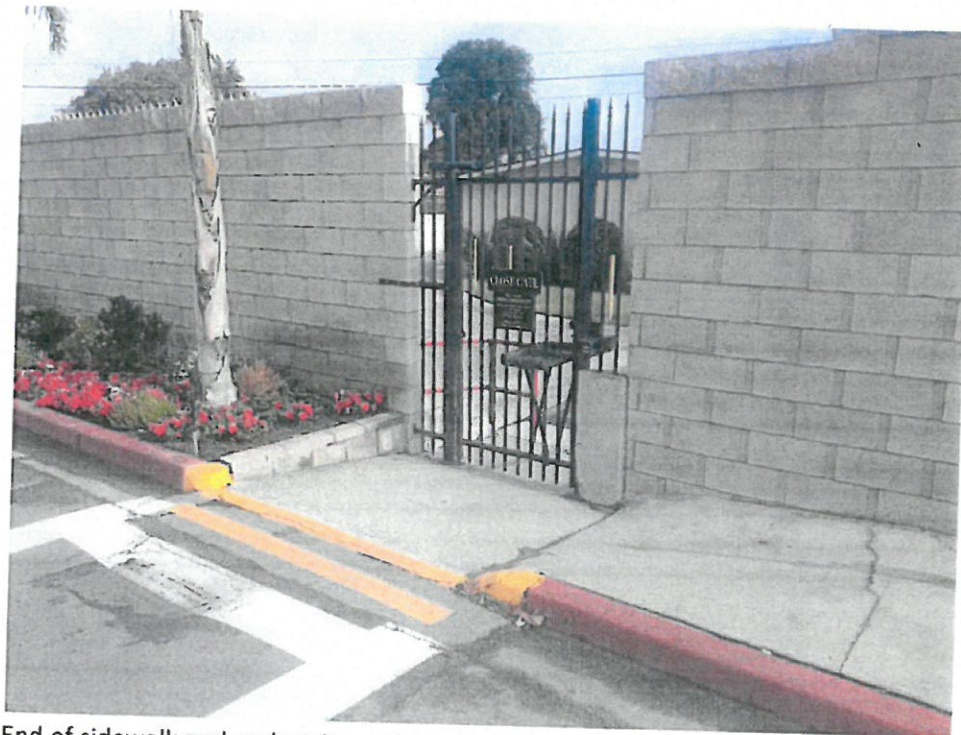
12. End of sidewalk and pedestrian gate west of St. Andrews gate.

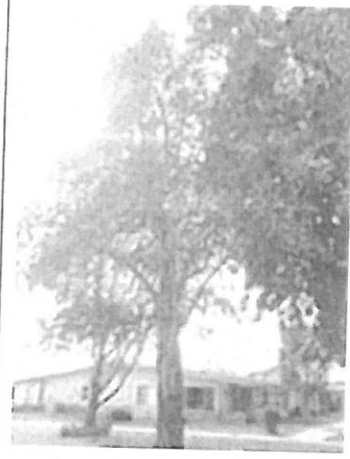
<p>Site 23 <i>Alnus rhombifolia</i> - White Alder</p> <p>This Alder tree is in competition with the rubber tree, and the rubber tree should be pruned back to allow space for the Alder.</p> <p>There are several large wounds on the top sides of lateral branches. These could have a variety of causes, but bark loss injuries are usually due to root cutting or squirrel chew. These bark loss wounds that run the length of the branches should be monitored. This tree should have an aerial inspection immediately to determine whether there is a hazard of wind throw.</p> <p>The tree should be maintained for head height clearance.</p> <p>Maintenance: two hours with climber Next Service: now Priority: high</p>

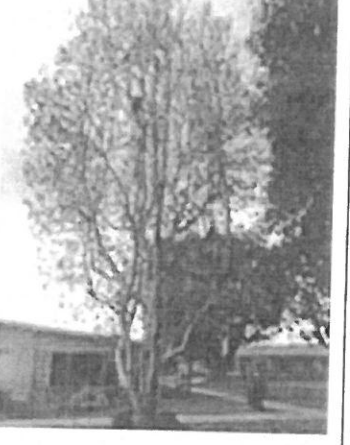
<p>Site 24 <i>Liquidambar styraciflua</i> - Sweet Gum</p> <p>This tree has a very large tearout wound on the South Eastern side of the trunk. The wound site is actively decaying, and there is soft, pithy wood within the heartwood of the tree. Ultimately, this wound site will limit the tree's lifespan.</p> <p>The tree is out of balance because nearly all of its foliage is on the North Western side. This will predispose the tree to failing to the Northwest. Some of the foliage on the North Western side can be thinned to train the tree back to the South East. However, eventually this tree will need to be removed because the decay will advance on the interior of the tree and reduce its structural integrity.</p> <p>This tree should be monitored annually for the advance of decay, and if more than two thirds of the heartwood of the tree is decayed, then it should be considered for removal.</p> <p>Maintenance: one hour Next Service: now Priority: medium</p>
